NOTICE OF VIOLATION #5576E

Photograph Enclosure for NOV #5576E
Greenleaf, L.L.C.
Neosho, MO

TO: Hazardous Waste Enforcement File
Greenleaf, L.L.C.
Neosho, Missouri
MOR000526152

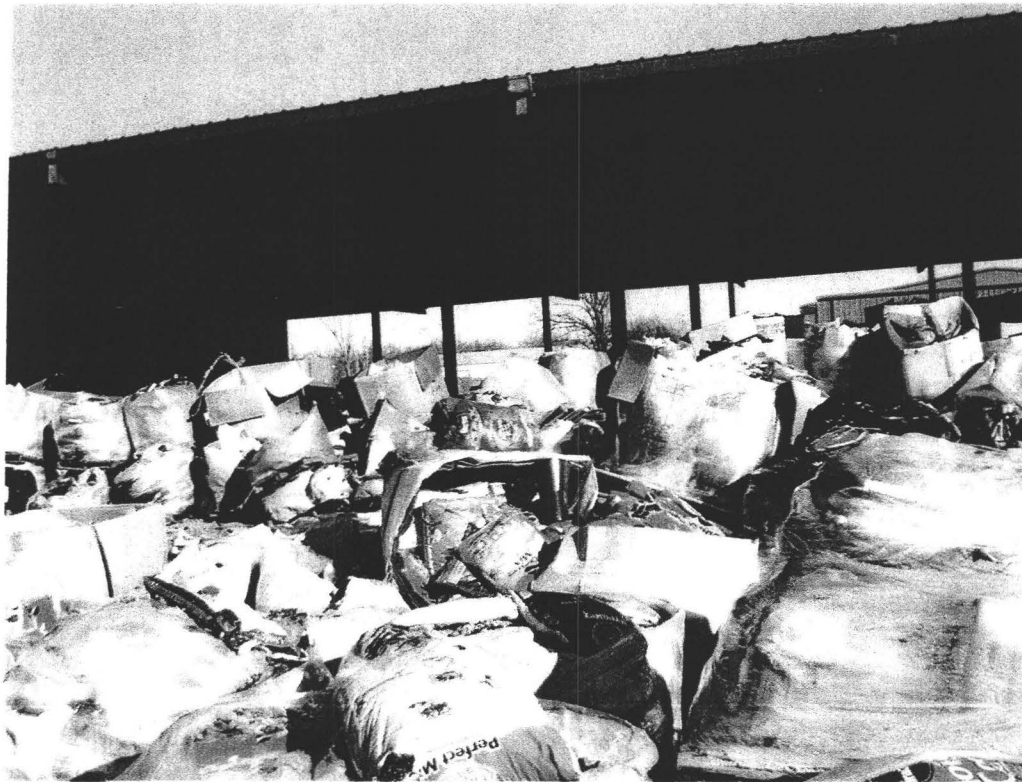
Picture 1

Description: The area between Building 2 and Building 3 at Greenleaf. Notice the inadequate aisle space for personnel and emergency equipment.

- 13) Failure to provide adequate aisle space; 10 CSR 25-5.262(1) incorporating 40 CFR 262.34(a)(4) referencing 40 CFR 265.35. Hazardous waste must be stored so that there is adequate aisle space to allow the unobstructed movement of personnel and emergency equipment in and around the containers. The pallets, containers, and boxes in and around Buildings 1, 2, and 3 were stored in such a manner as to obstruct the movement of personnel and emergency equipment (see photographs 1, 2, 16 and 19).

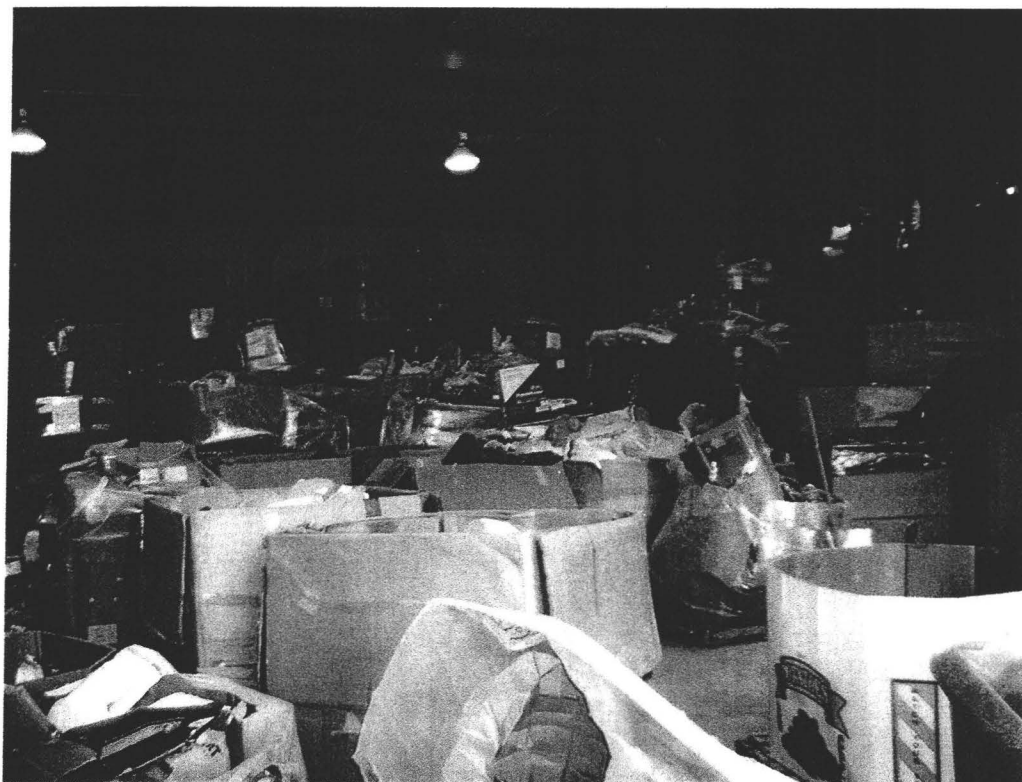
Picture 2

Description: Inside Building 1 of the Greenleaf facility. Notice the inadequate aisle space for personnel and emergency equipment.

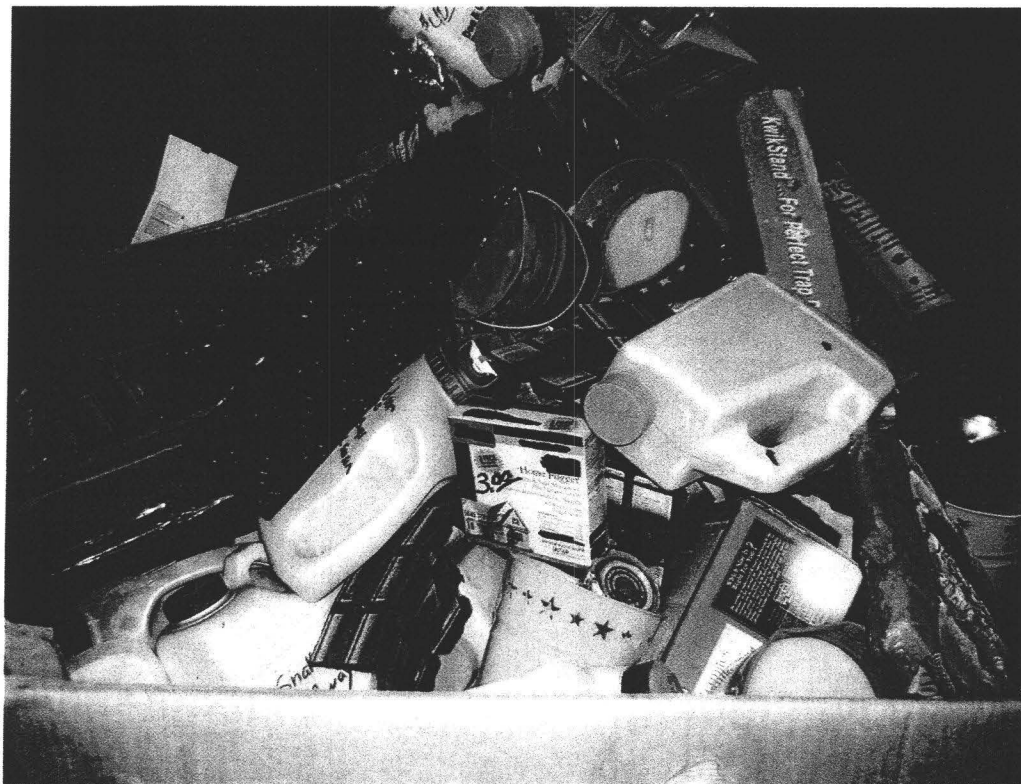
Picture 3

Description: An example of waste at Greenleaf, L.L.C.

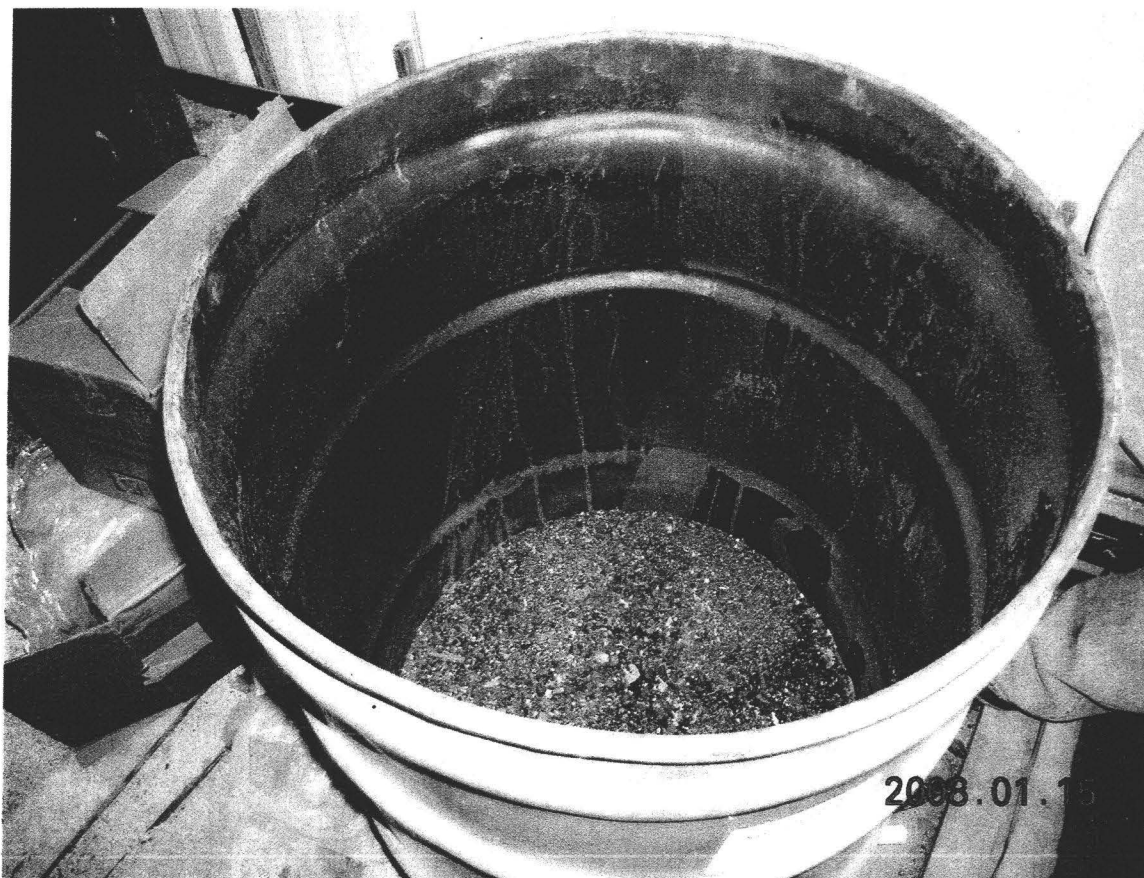
Picture 4

Description: Floor sweepings in Building 1.

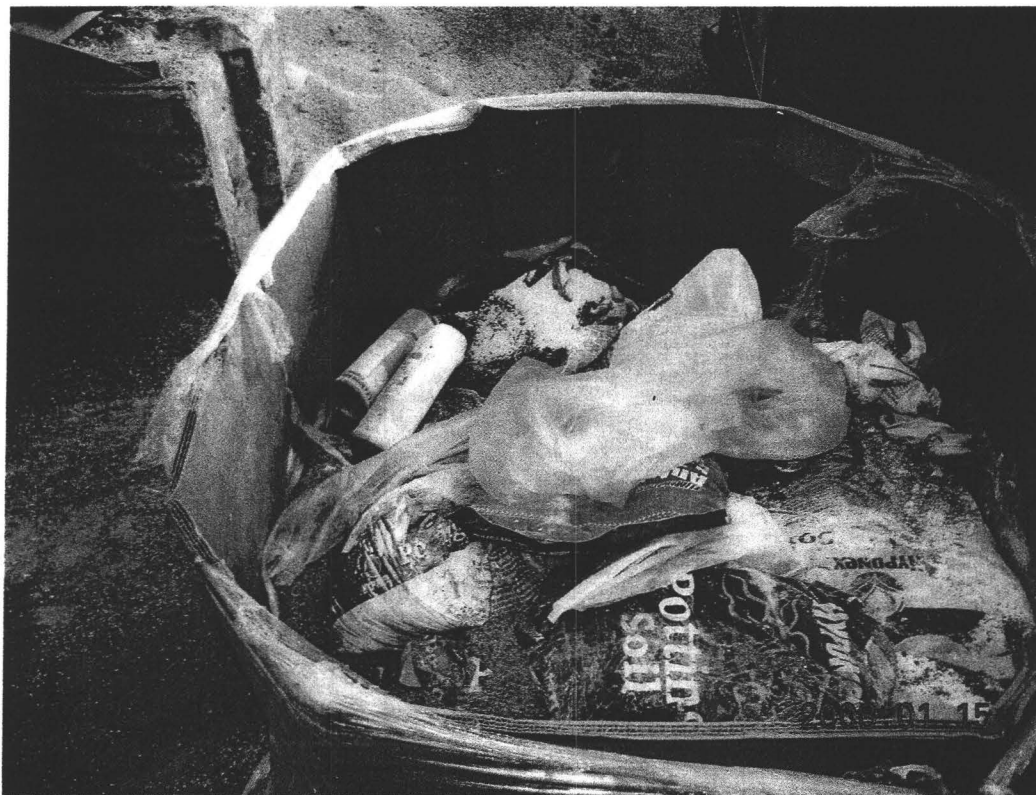
Picture 5

Description: An example of a Gaylord box with spilled pesticides and unidentified bags in Building 1.

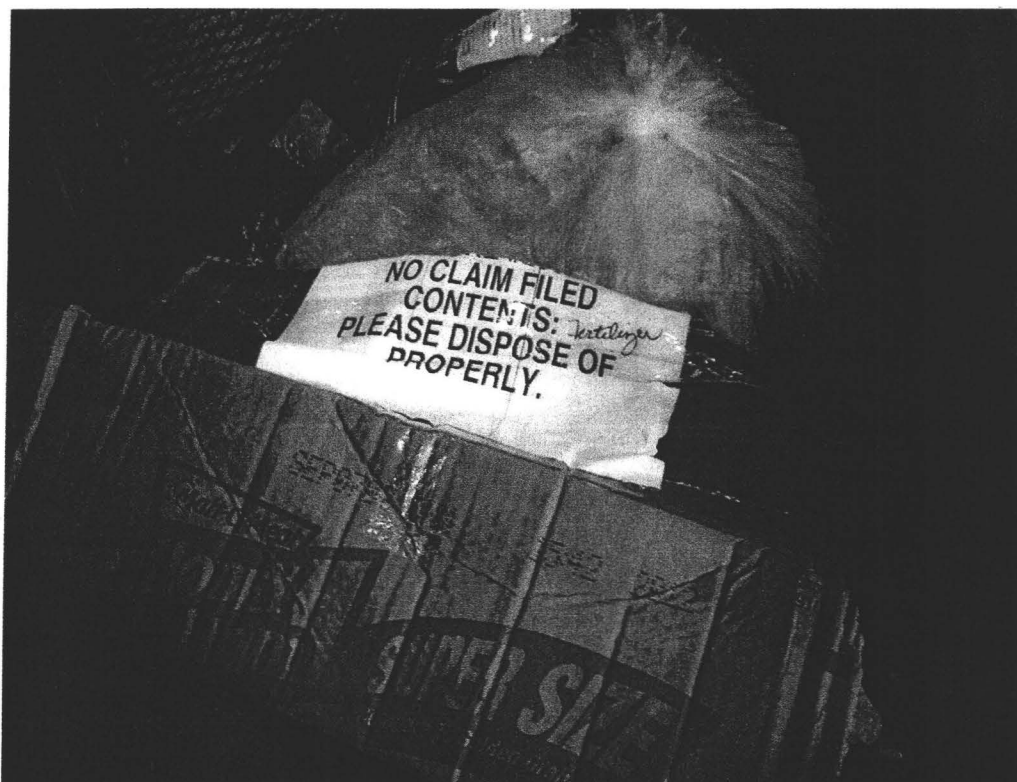
Picture 6

Description: An example of unidentified material marked for disposal.

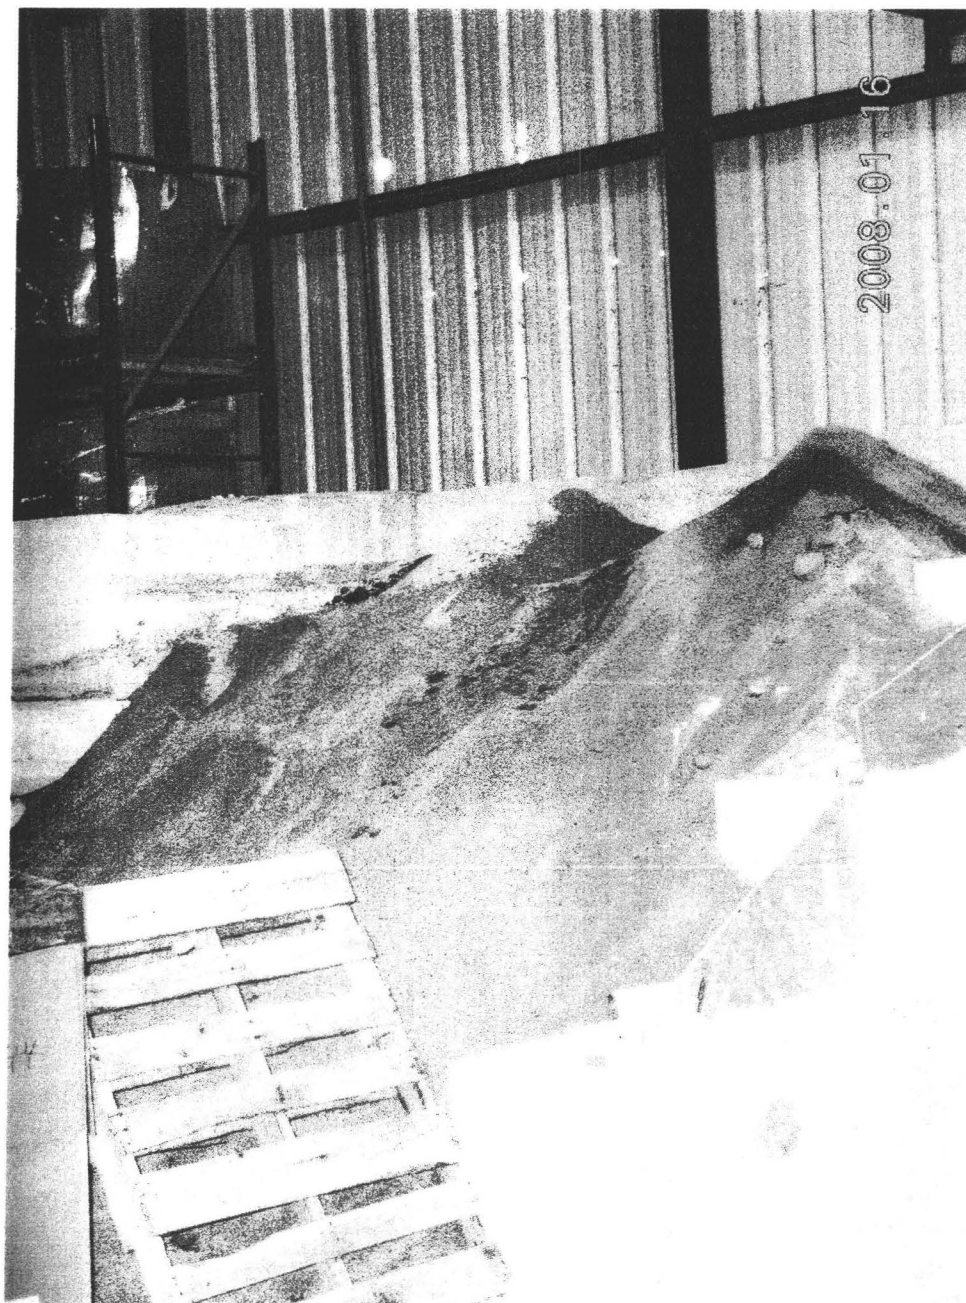
Picture 7

Description: View of Pile 1 in Building 1. The pile is a mixture of granular pesticides under the Stop Sale, Use, or Removal Order (SSURO). The dry pesticide is from several different sources including Sevin, which contains carbaryl, a U279 listed hazardous waste.

- A. Greenleaf received hazardous waste, specifically liquid Sevin containing carbaryl, a U279 listed hazardous waste (see photograph 15).
 - B. Greenleaf stored hazardous waste in an unpermitted containment building. Without a permit, Greenleaf may only contain hazardous waste in containers or tanks. Greenleaf stored a listed hazardous waste (U279) in a pile. It is also likely that the pile of "Weed and Feed" is a toxic hazardous waste for 2,4-D (see photographs 7 through 9).

- C. Consolidating liquid hazardous waste with non-hazardous waste liquid for disposal (see photographs 12 through 15).
- 3) Materials were accumulated speculatively; 10 CSR 25-4.261 incorporating 40 CFR 261.1(c)(8). Greenleaf did not have a feasible means of recycling the pesticides that it received from Wal-Mart. They were not in compliance with pesticide regulations, did not have the proper equipment, and did not have enough employees to recycle pesticides properly. In addition, Greenleaf had no intention of recycling the liquid pesticide and fertilizer that they had on site. They had no packaging or bottling equipment for liquids. In 2007, Greenleaf shipped 192, 55-gallon drums of liquid pesticide and fertilizer as waste. Aerosol cans were present on site. Aerosol cans cannot be recycled by Greenleaf due to their packaging. The aerosol cans are being accumulated speculatively (see photographs 7 through 17).

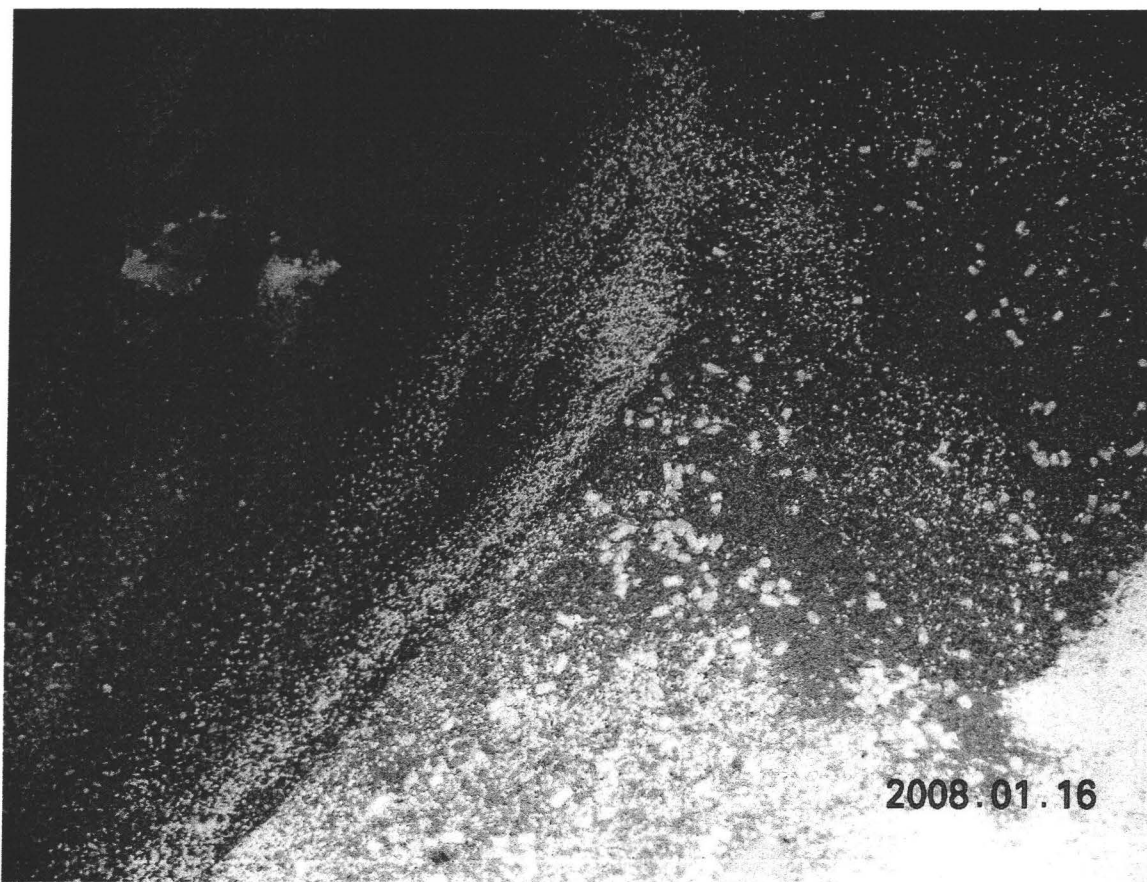
Picture 8

Description: Up close view of Pile 1 in Building 1. The pile is a mixture of granular pesticides placed under the SSURO. The dry material is from several different sources. Note multiple colors and sizes of grains.

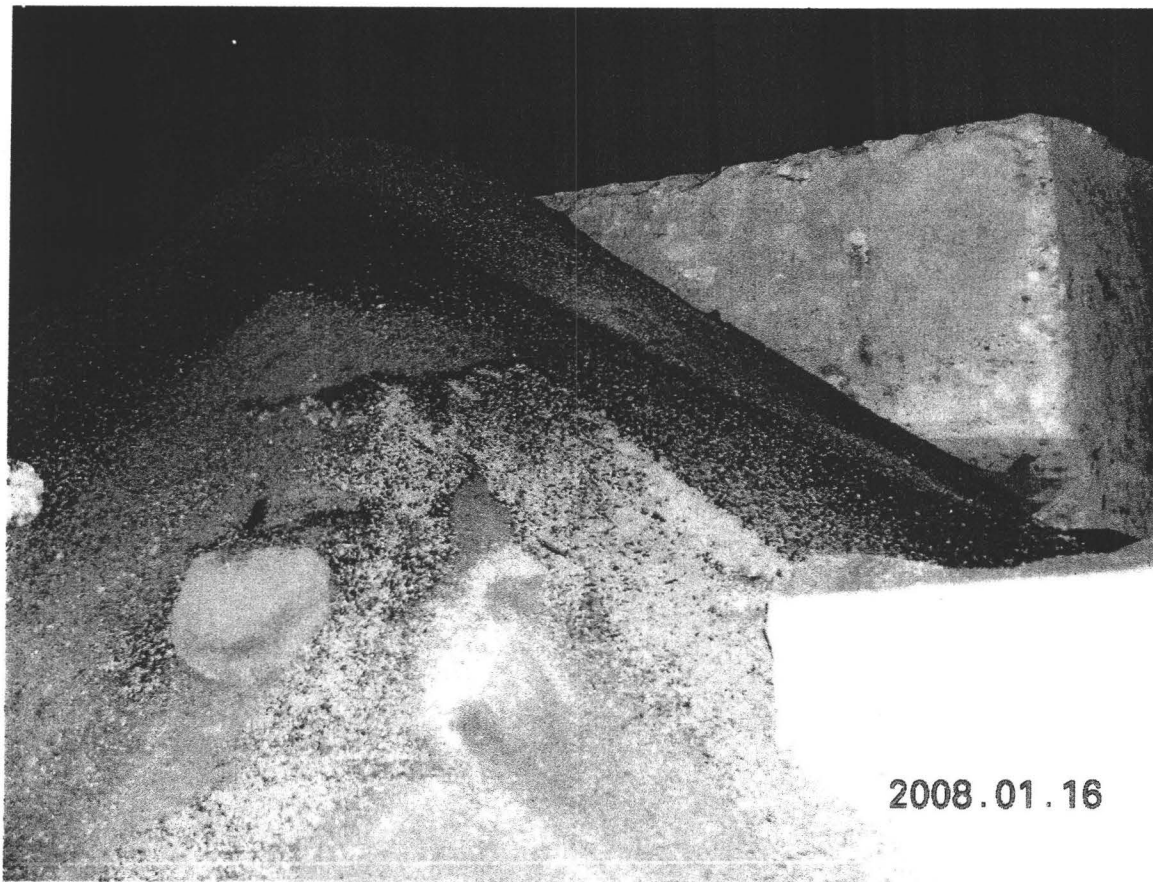
Picture 9

Description: Another up close view of Pile 1 in Building 1. The pile is a mixture of granular pesticides placed under the SSURO. The dry material is from several different sources. Note multiple colors and sizes of grains.

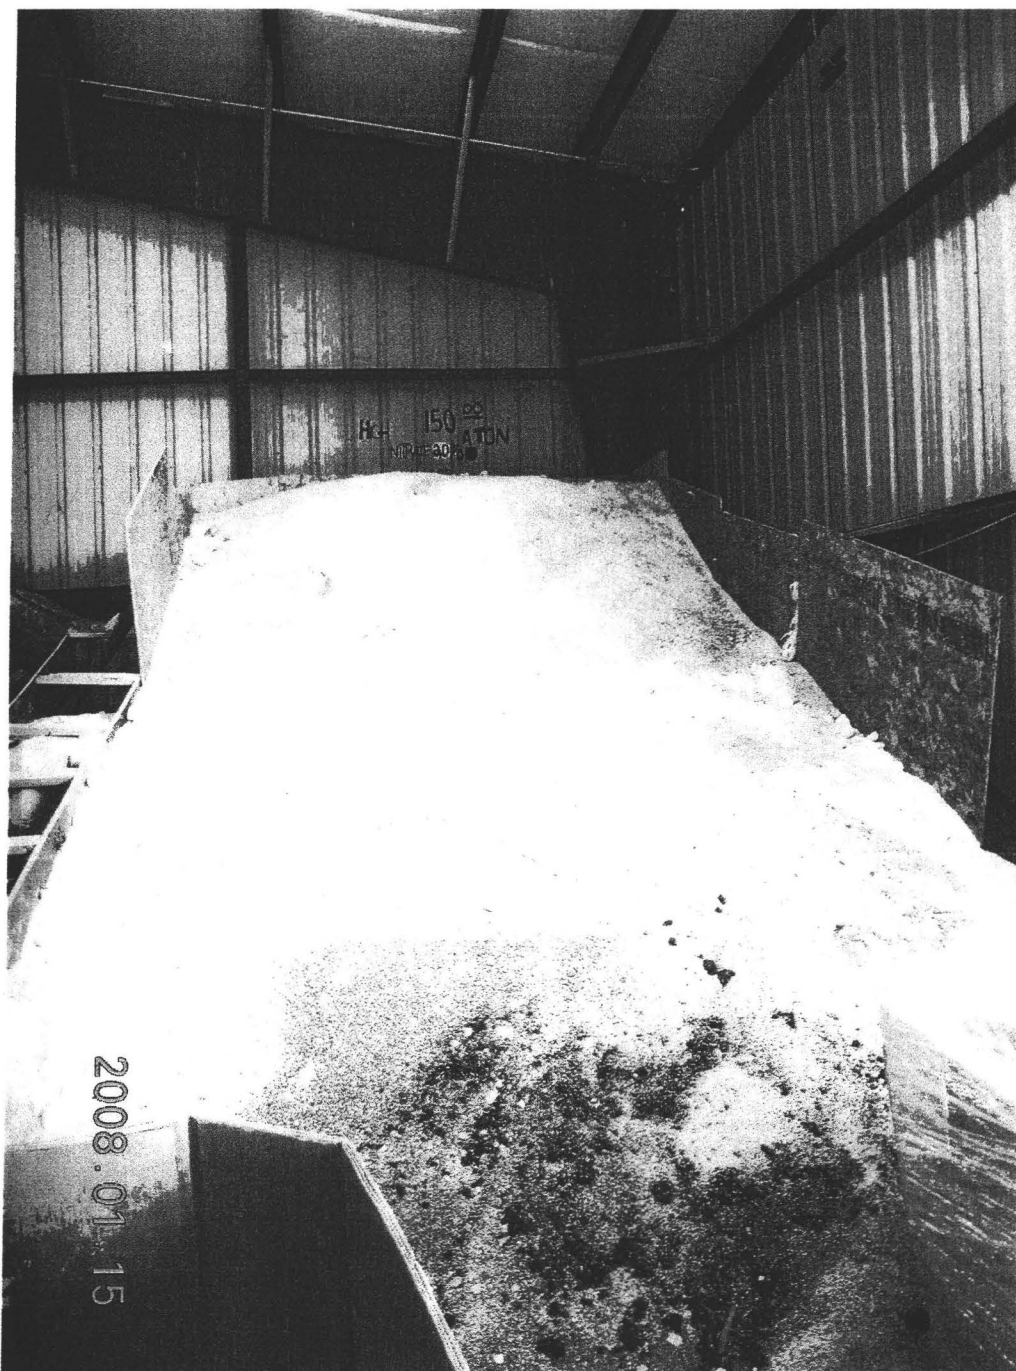
Picture 10

Description: View of Pile 4 in Building 1. The pile is a mixture of granular pesticides placed under the SSURO. The pile is from several different sources and contains 2,4-D.

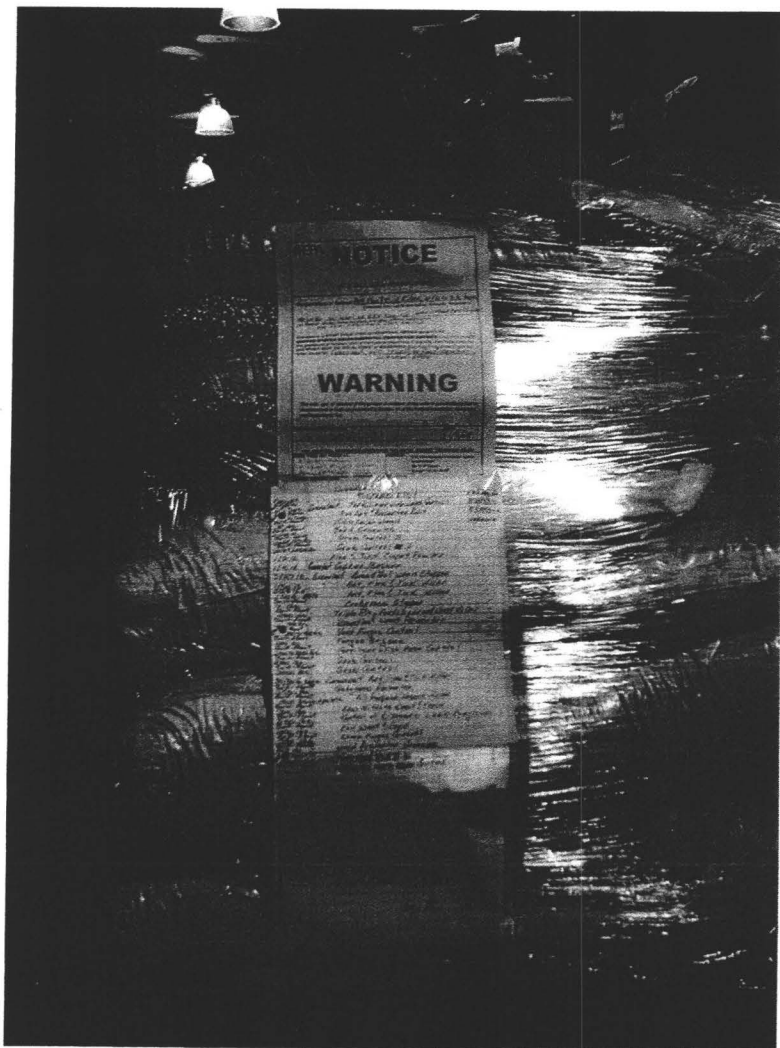
Picture 11

Description: One of the pallets of pesticides placed under the SSURO in Building 1.

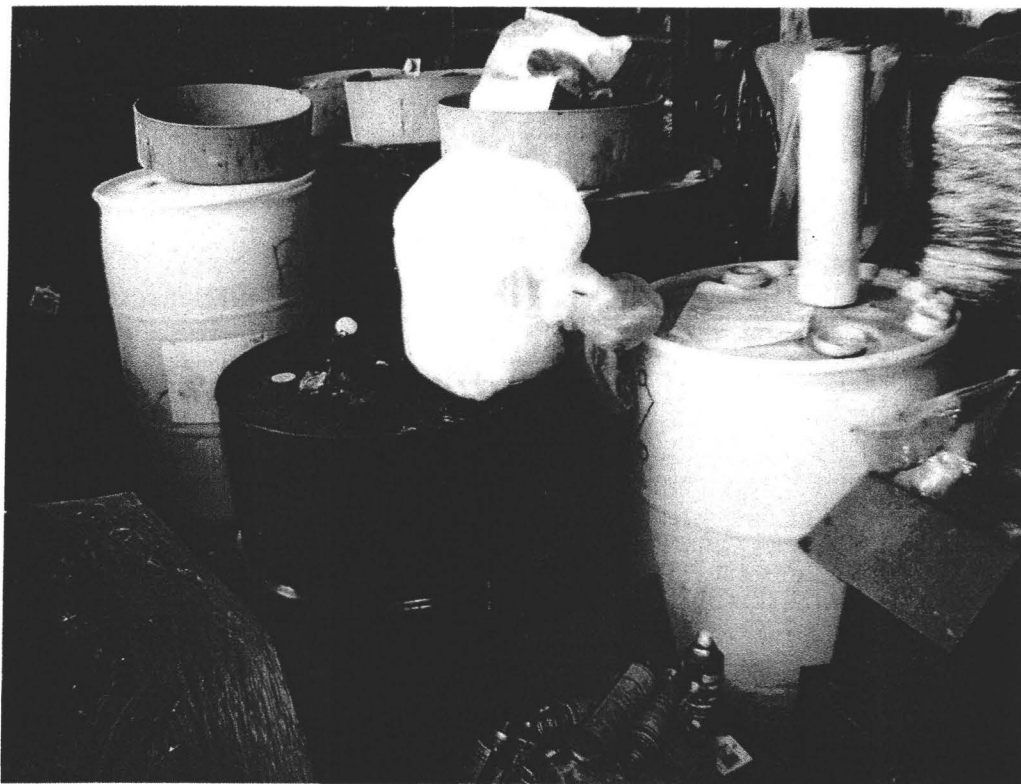
Picture 12

Description: Drums of waste liquid and aerosol cans in Building 2.

- F. Aerosol cans (see photograph 12).
- 2) Operation as a treatment, storage, or disposal (TSD) facility without prior approval from the department; Section 260.390(1) Revised Statutes of Missouri (RSMo). The following actions are considered treatment, storage, and disposal of hazardous waste at the facility and operation as a TSD facility without a permit from the department.

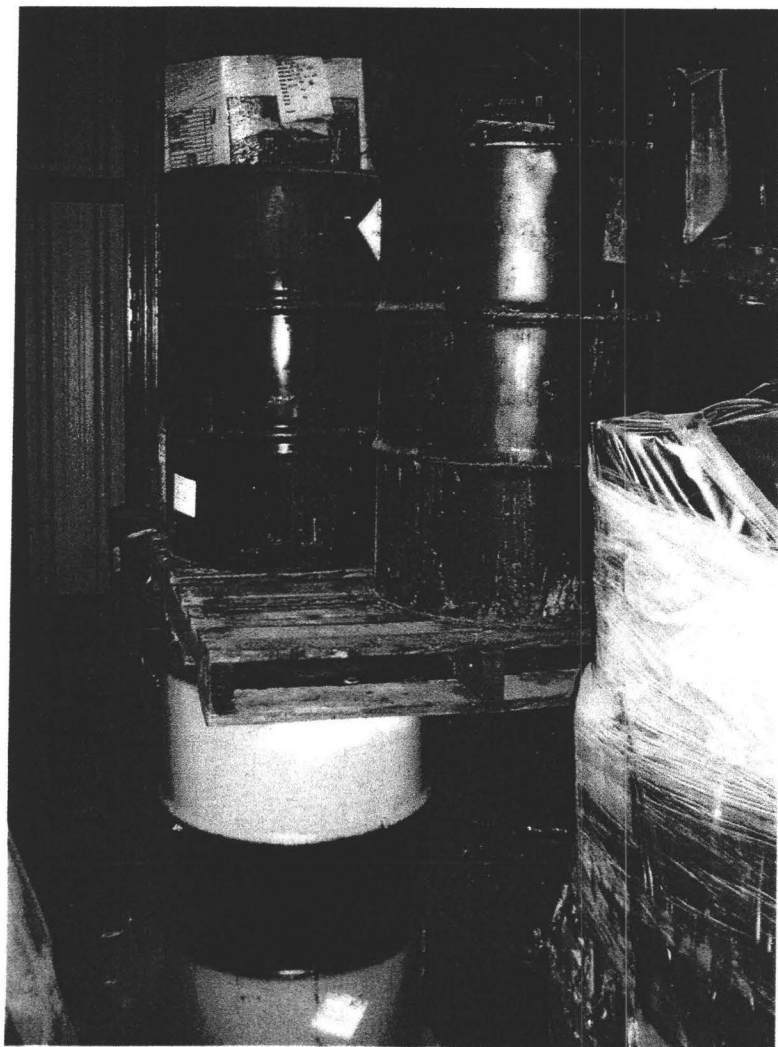
Picture 13

Description: Drums of waste liquid in storage in Building 2.

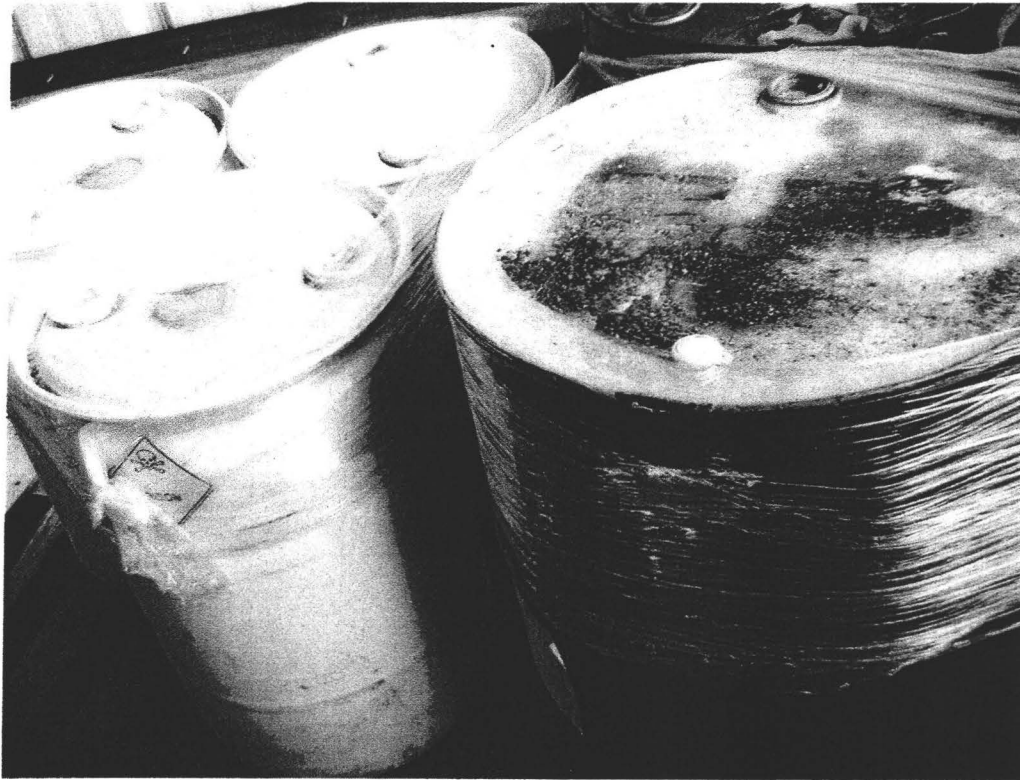
Picture 14

Description: Drums of waste liquid in storage in Building 3.

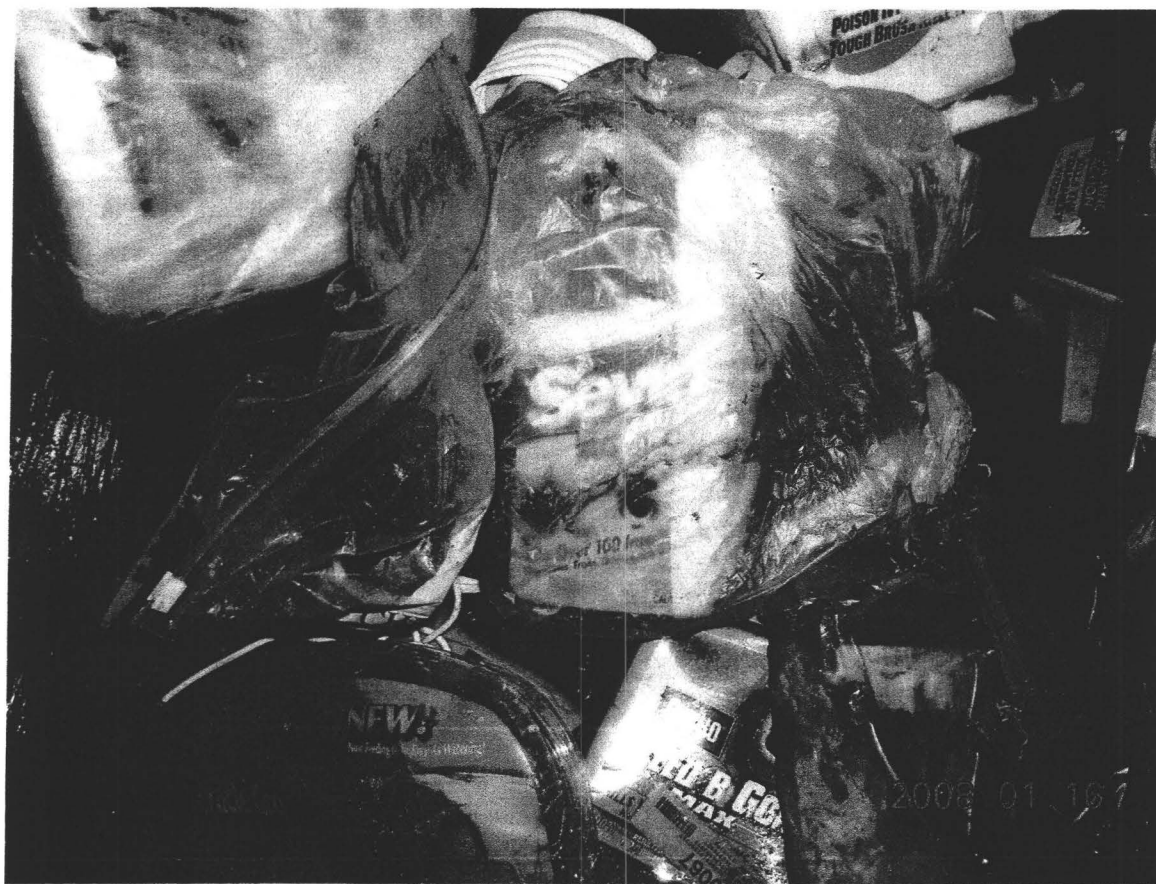
Picture 15

- 7) Failure to keep containers of hazardous waste closed during storage; 10 CSR 25-5.262(1) incorporating 40 CFR 262.34(a)(1) referencing 40 CFR 265.173(a). All waste containers must be closed in such a way as to prevent spillage, minimize volatilization, and minimize employee contact with the waste. A container of liquid Sevin which contains carbaryl, a U279 listed hazardous waste, was stored in a plastic bag located in a cardboard box (see photograph 15). This does not meet the definition of closed container.

- 8) Failure to clearly mark containers as hazardous waste; 10 CSR 25-5.262(1) incorporating 40 CFR 262.34(a)(3). The container of liquid Sevin was not marked "Hazardous waste" (see photograph 15).

- 9) Failure to package/label/mark waste per Department of Transportation (DOT) regulations during the entire on-site storage period; 10 CSR 25-5.262(2)(C)1. The container of liquid Sevin was not labeled per DOT regulations during the entire on-site storage period (see photograph 15).

- 10) Failure to include the beginning date of accumulation on containers of hazardous waste; 10 CSR 25-5.262(1) incorporating 40 CFR 262.34(a)(2). The beginning date of accumulation must be provided on all containers of hazardous waste during the entire on-site storage period. The container of liquid Sevin was not identified with a date of when it was determined to be a waste (see photograph 15).

Description: View of liquid Sevin, a U279 listed hazardous waste in Building 2. Note that it is leaking and improperly containerized. The container does not have the proper marking or labels.

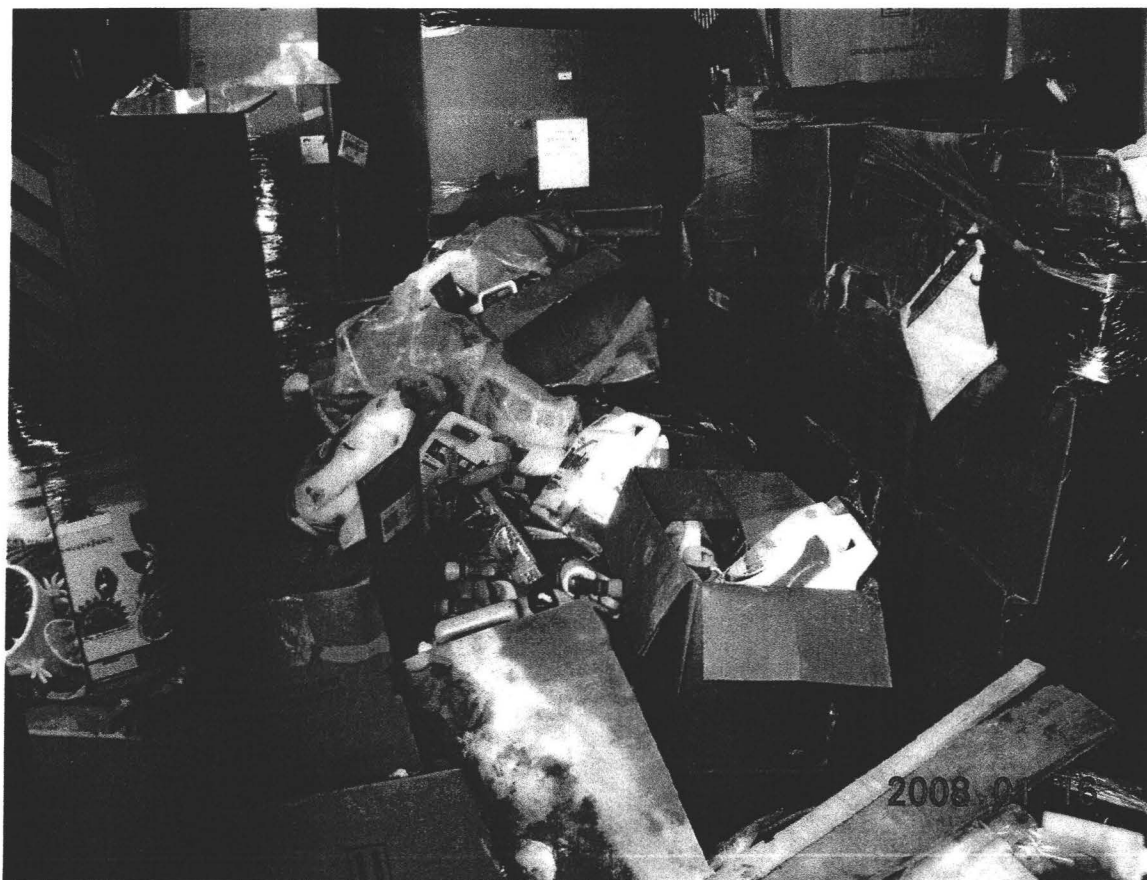
Picture 16

- 11) Failure to inspect and maintain the facility (weekly); 10 CSR 25-5.262(2)(C)2.C.(I) and (II) referencing 40 CFR 265.174. The regulations require that the inspection identify the types of problems that are to be looked for, identify the person making the inspections, a notation of observations, and the date of any repairs or remedial actions. Inspections were not done of waste storage areas at Greenleaf (see photographs 16 through 20).

- 12) Failure to conduct a daily inspection of areas subject to spills, i.e. waste handling areas; 10 CSR 25-5.262(2)(C)2.C.(II). No daily inspections were being conducted on the north end of Building 2, where liquid spills were observed. Numerous spills were apparent throughout the facility and were not cleaned up (see photographs 16 through 20).

- 15) Failure to provide adequate and proper spill control, decontamination, and safety equipment (fire blankets, respirator, SCBA, absorbents, etc.); 10 CSR 25-5.262(2)(C)2.E. The facility is lacking in spill control and decontamination equipment. Information on the location and capabilities of the equipment must be provided in the Contingency Plan (see violation 17). There did not appear to be any decontamination equipment in Buildings 2 and 3 (see photographs 16 through 19).

Description: An example of spilled liquid waste in Building 2. Notice the inadequate aisle space for personnel and emergency equipment.

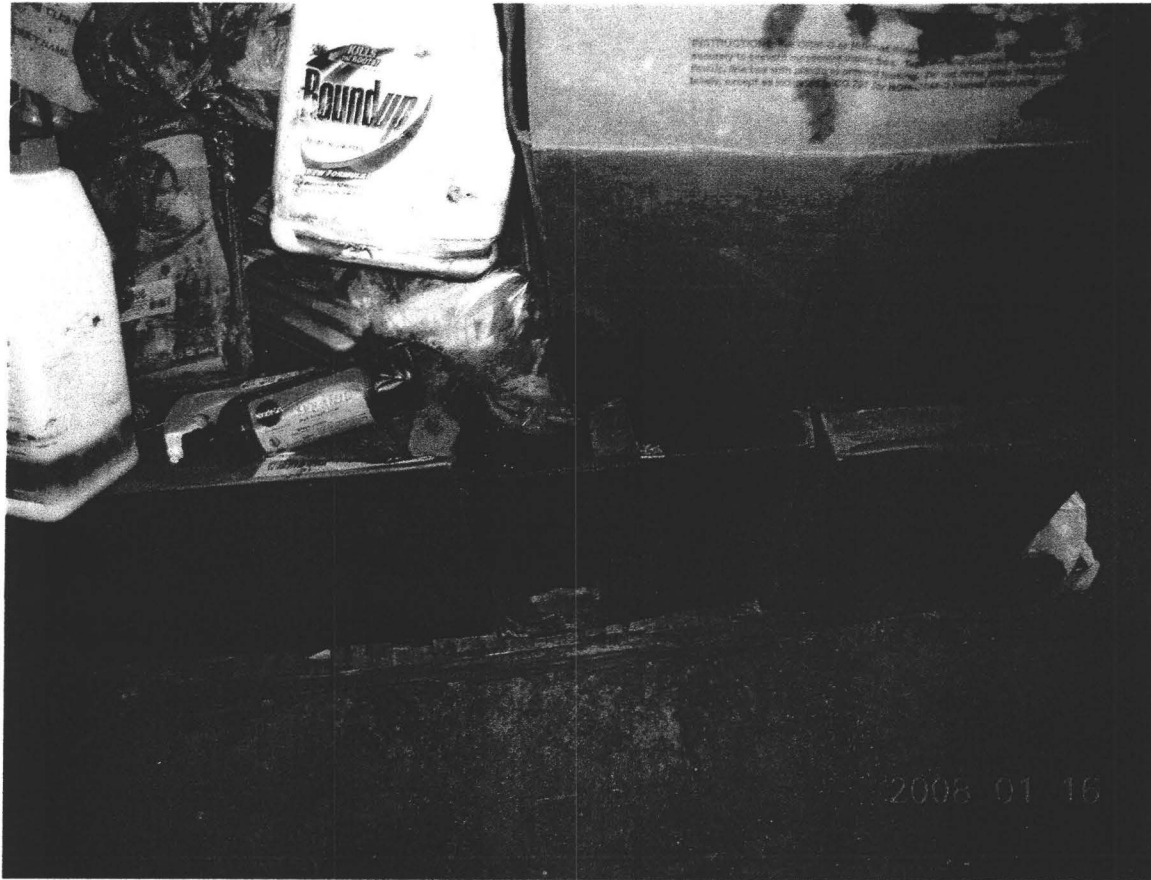
Picture 17

Description: An example of spilled liquid waste in Building 2.

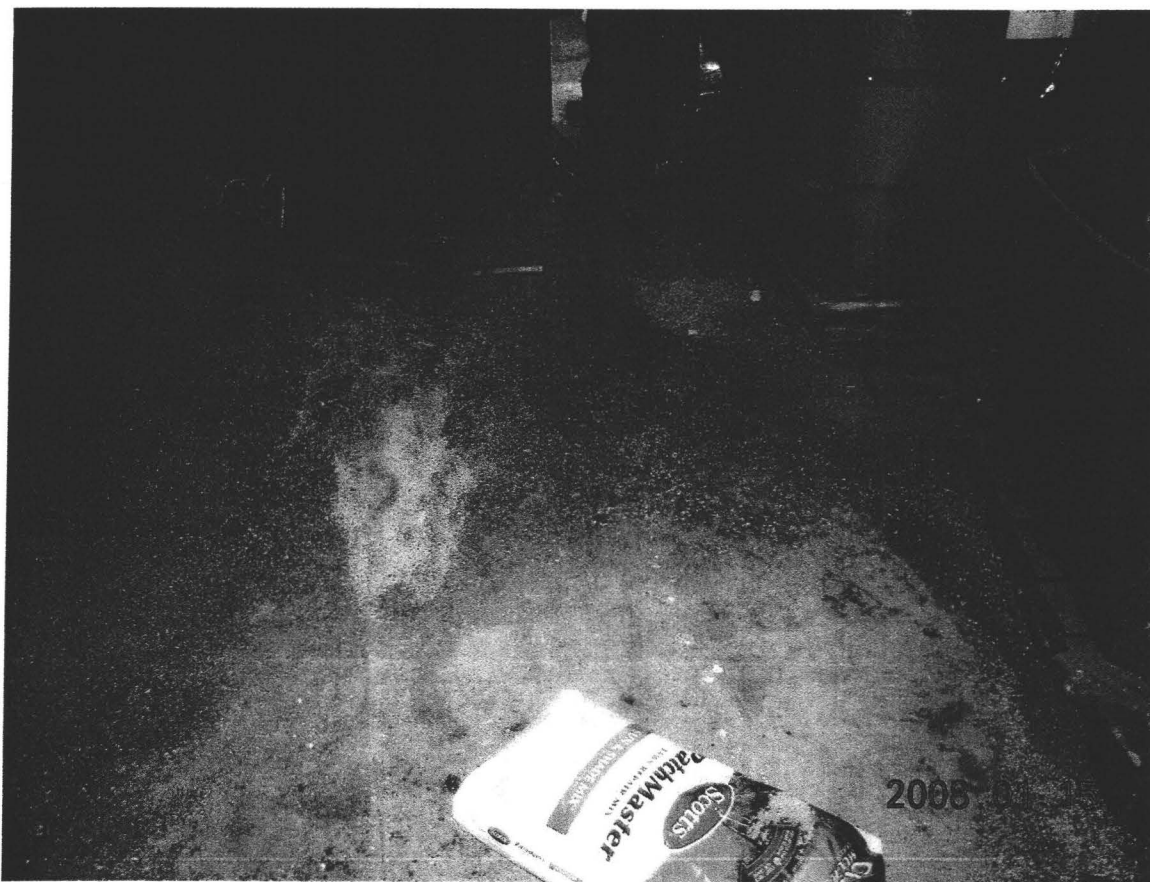
Picture 18

Description: An example of spilled dry material in Building 1.

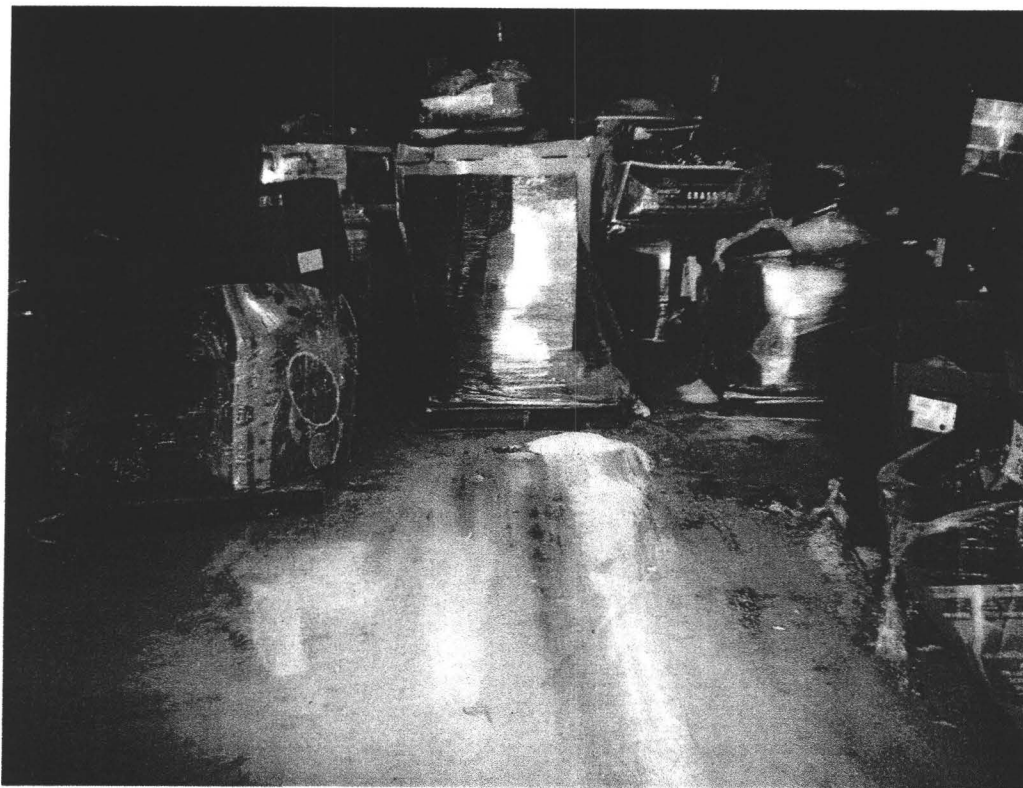
Picture 19

Description: An example of spilled dry material in Building 1. Notice the inadequate aisle space for personnel and emergency equipment.

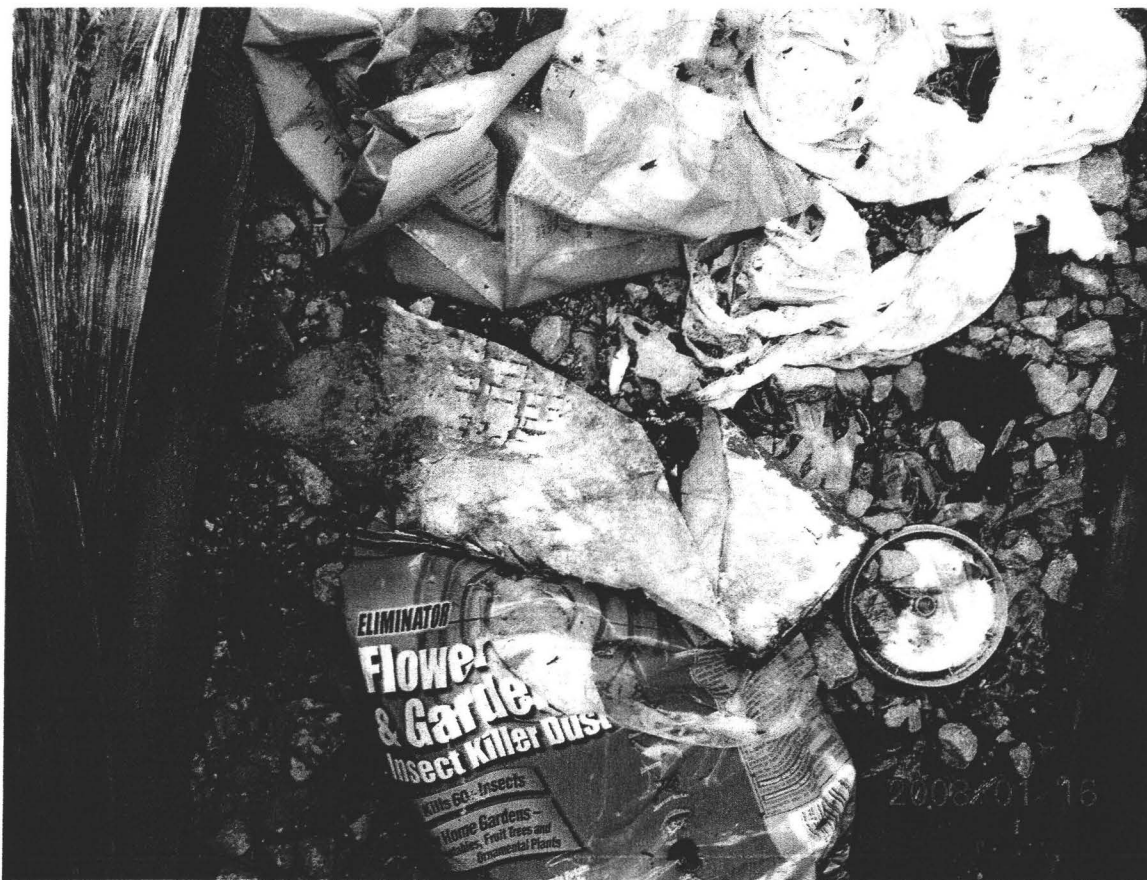
Picture 20

Description: An example of spilled dry pesticide outside near Building 3.

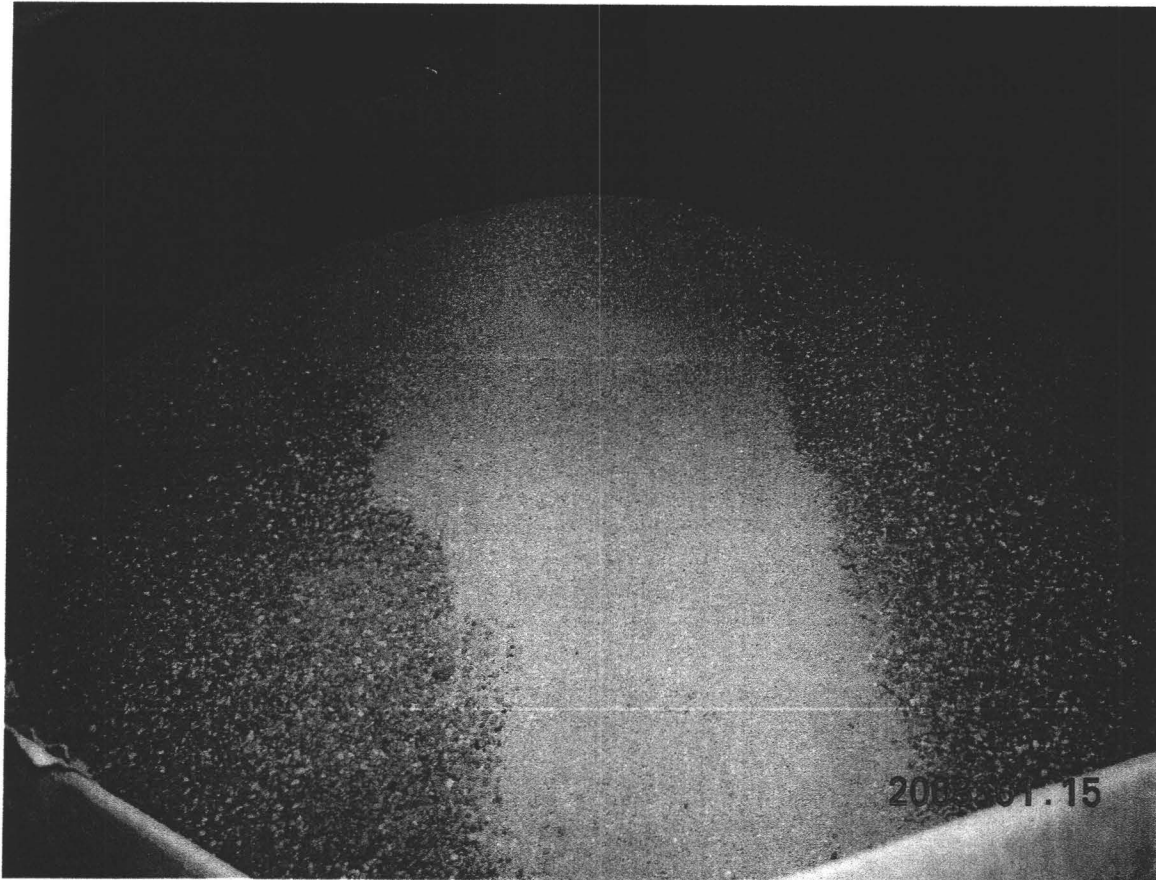
View of the Gaylord box containing two colors of granular material in Building 1.
